Joint Test Director  
Joint Logistics Over-the-Shore II  
Test and Evaluation

## ANALYSIS AND EVALUATION REPORT

JLOTS II

Throughput Test  
AUGUST 1985

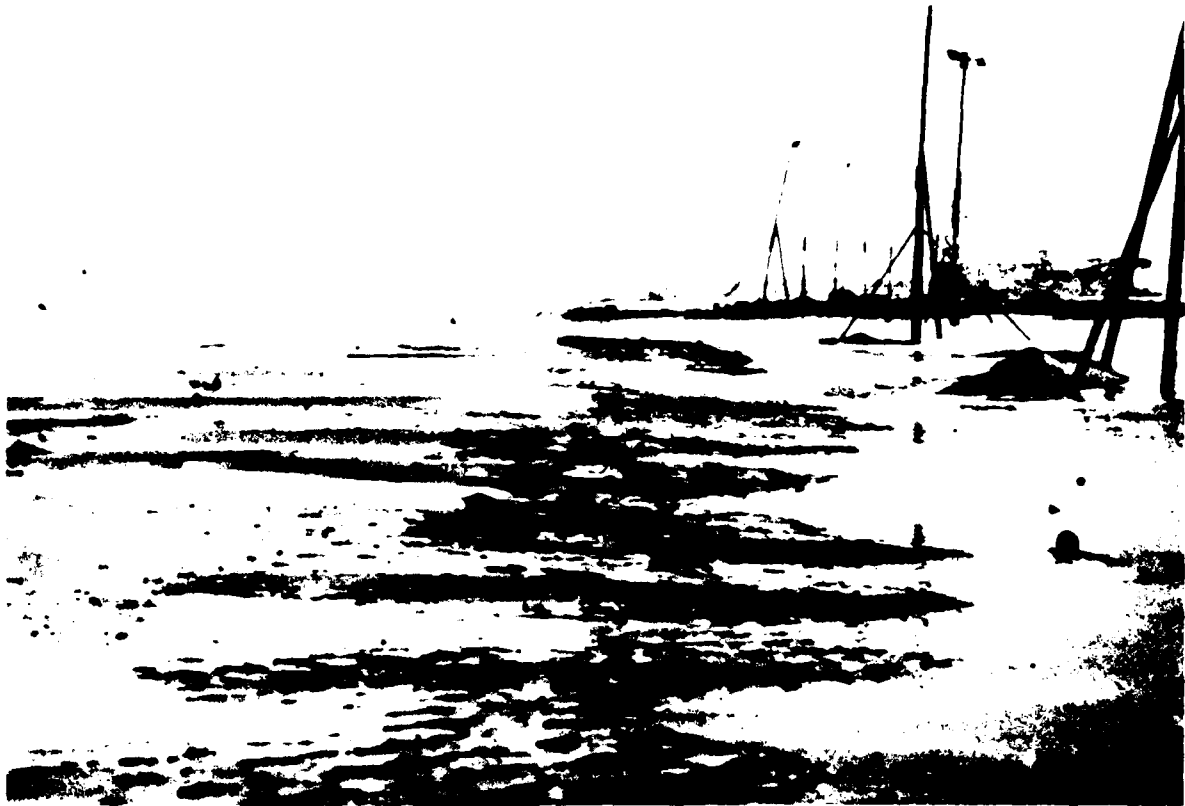
Figure 3-10 - Storm Damage to Beach Roadway

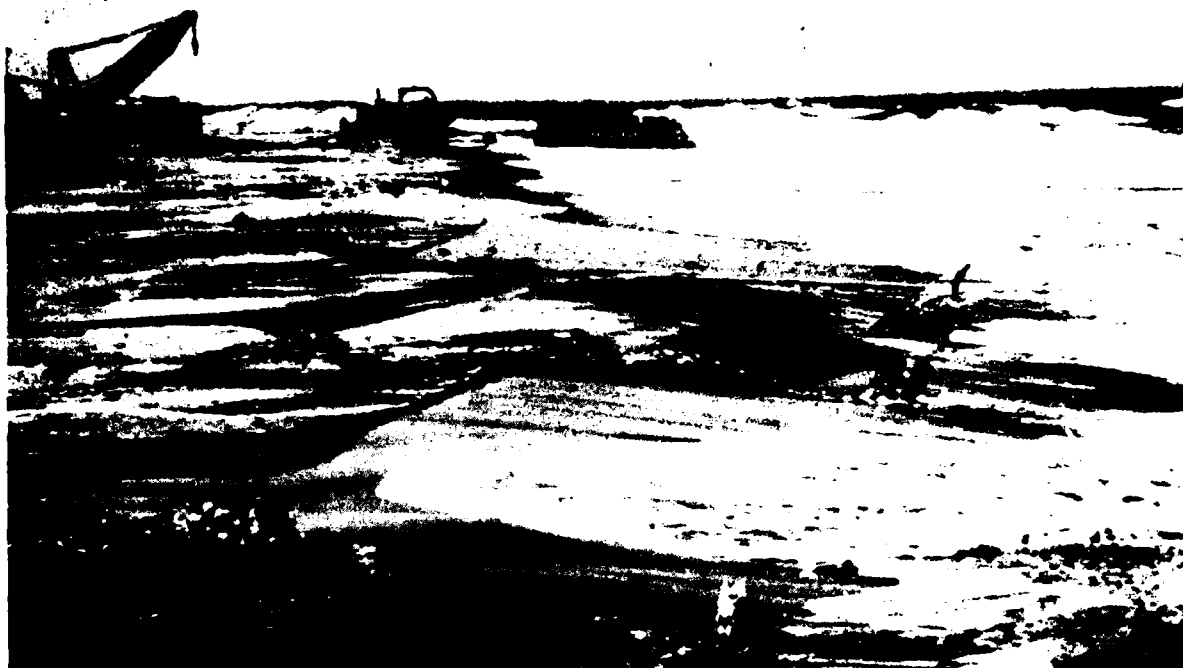
- The MOMAT along the Navy offload area, used for truck loading mats, was washed away in a storm (see Figure 3-11). Water rapidly eroded the stake foundations and allowed the panels to blow/float free.

Figure 3-11 - MOMAT Truck-Loading Mats Washed Away by Storm Procedures. Aside from the sequential lists of tasks addressed in the preceding tables, the only written procedure was a technical manual supplied with the MOMAT. No Army Service Manual exists for this type operation.

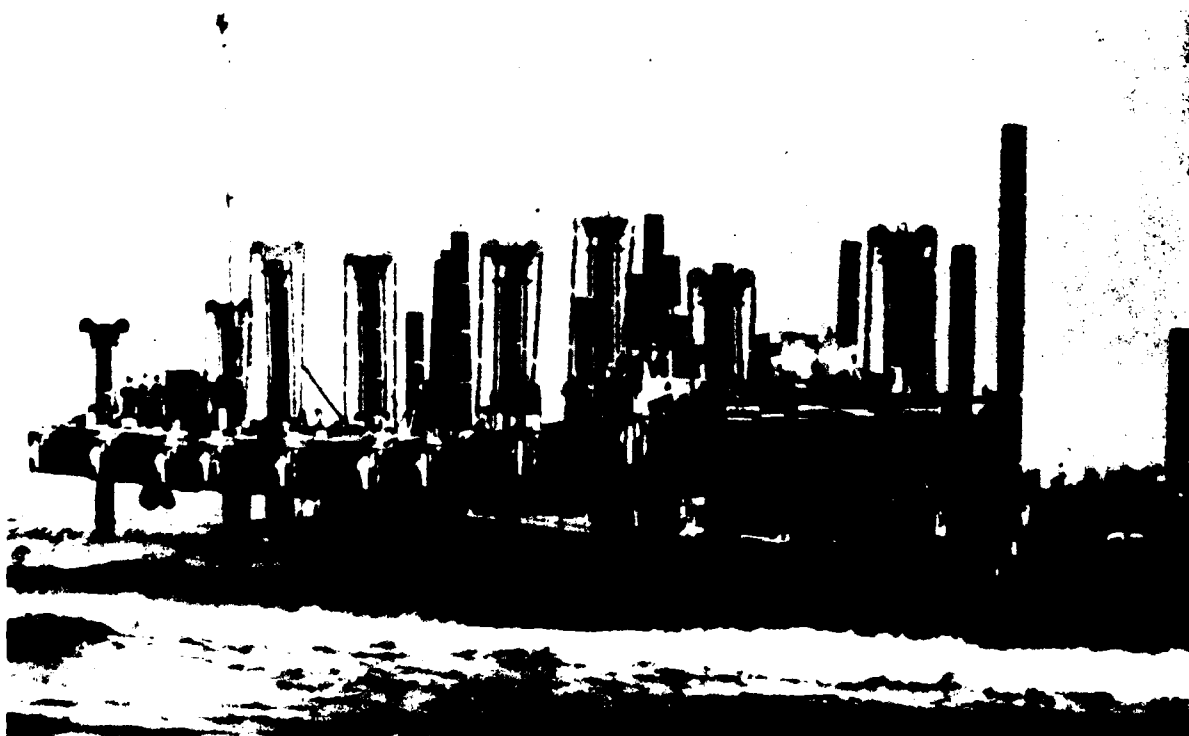
Jacking - The jacking system was transported on the Causeway Ferry which was moored to the pierhead sections of the ELCAS. After the piling were driven on sections 10, 11, and 12, the jacks were placed on appropriate piling, the sections separated from the rest of the pierhead, and jacking commenced (Figure 3-16). Some delays due to malfunctioning

Figure 3-16 - ELCAS Jacking

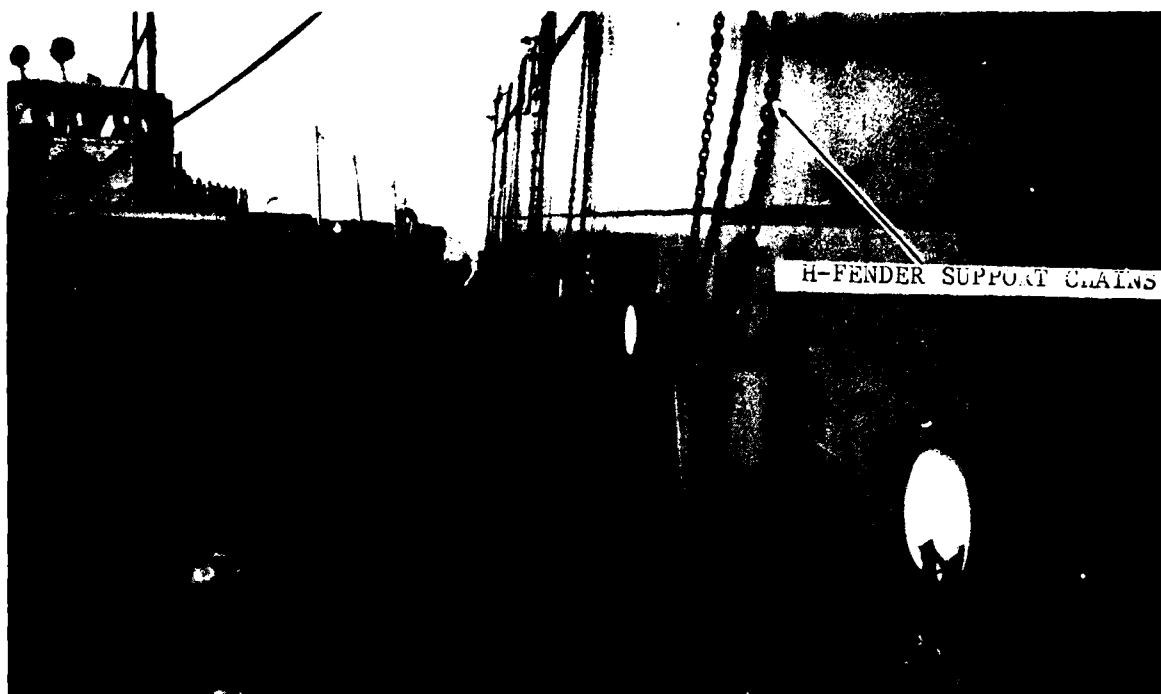
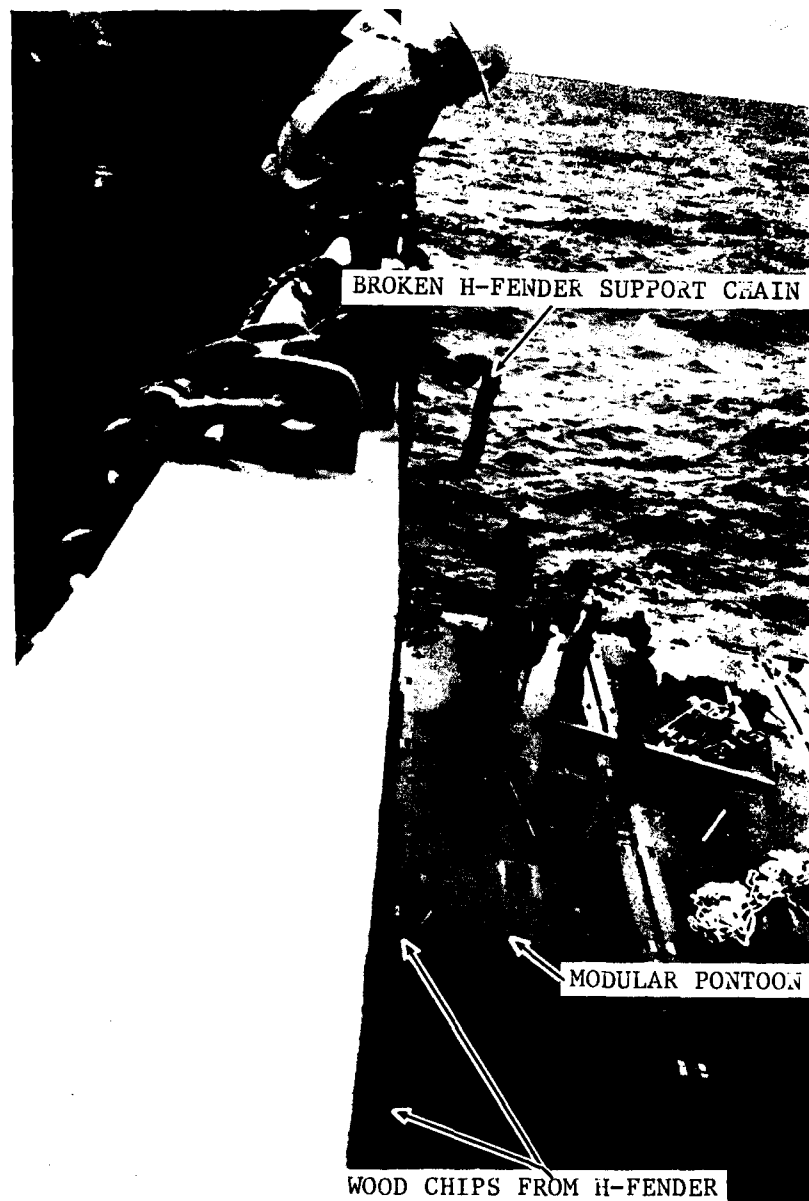
Figure 3-26 - T-ACS H-Fender Damage

Figure 3-26 (cont) - T-ACS H-Fender Damage  
3-56

The H-Fenders at the lighter stations were too short and would ride up on the Causeway Ferries. Mooring line arrangements were not standard for all lighters and caused minor delays and confusion. Lighter mooring is sea state sensitive and, generally, was not attempted in Sea State 3.

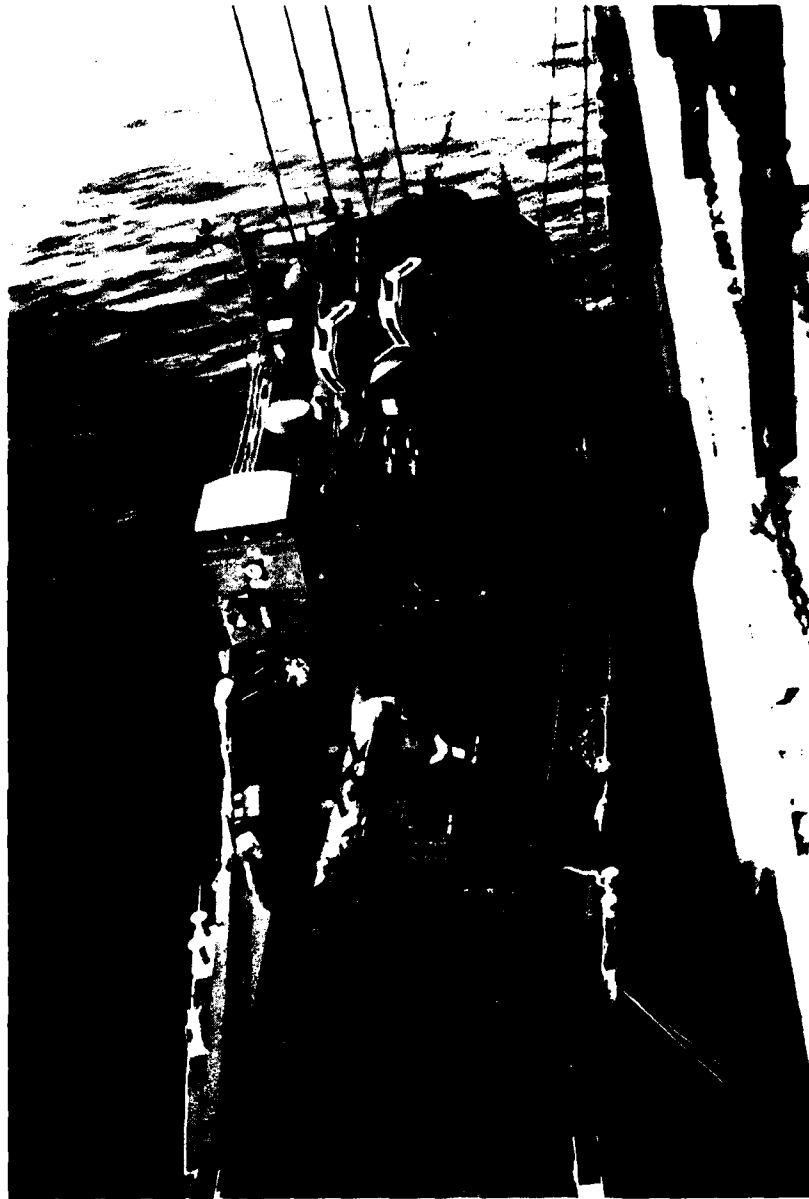
Figure 3-27 - Proposed Lighterage Fendering System

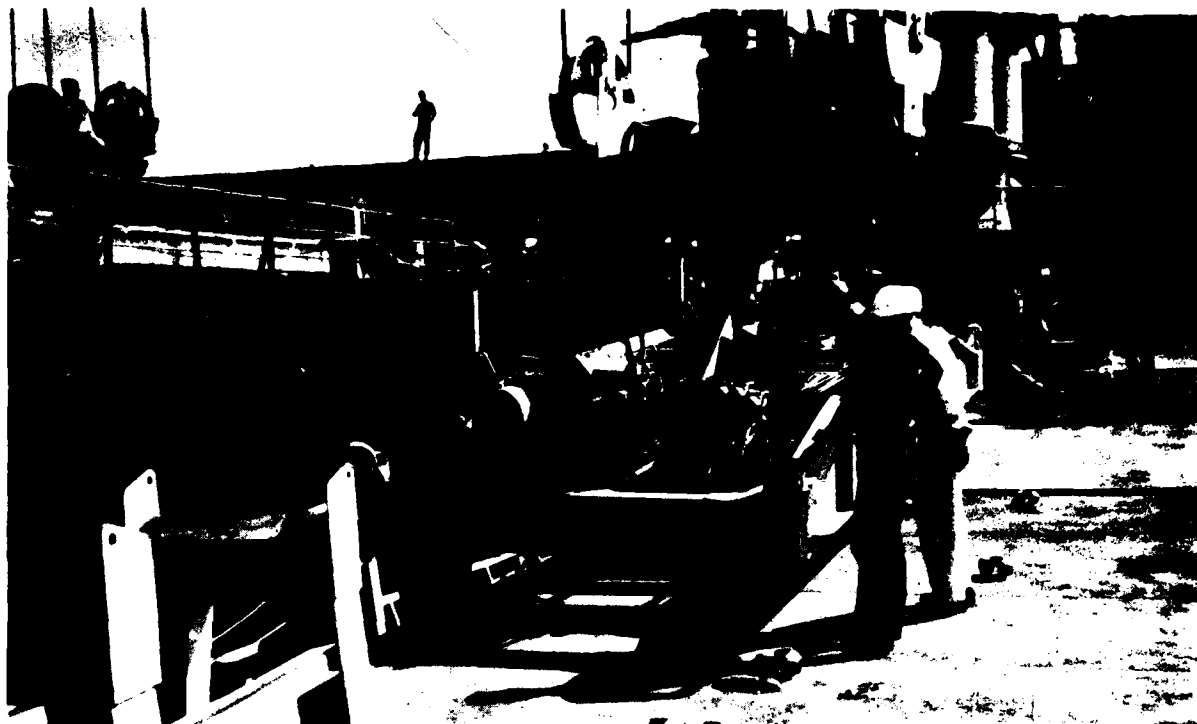
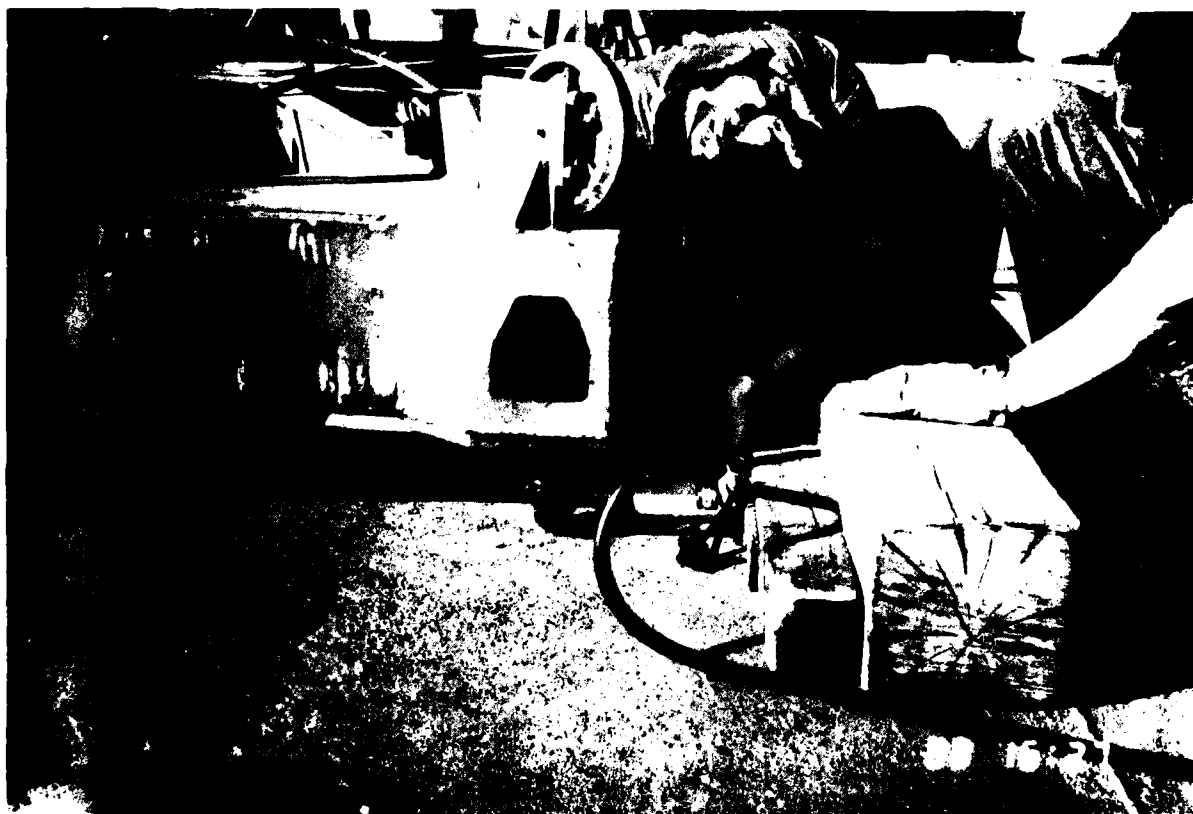
Figure 3-29 - Automatic and Manual Container Spreader Bars

Lighter Loading at T-ACS. During the Navy/USMC Phase, pendulation of the T-ACS remotely operated container spreader bars was found to be uncontrollable under the slightest ship roll condition (less than 1 deg). Army manual spreaders were acquired and tried, as were single point lift, four-leg slings. The slings soon became the preferred equipment.

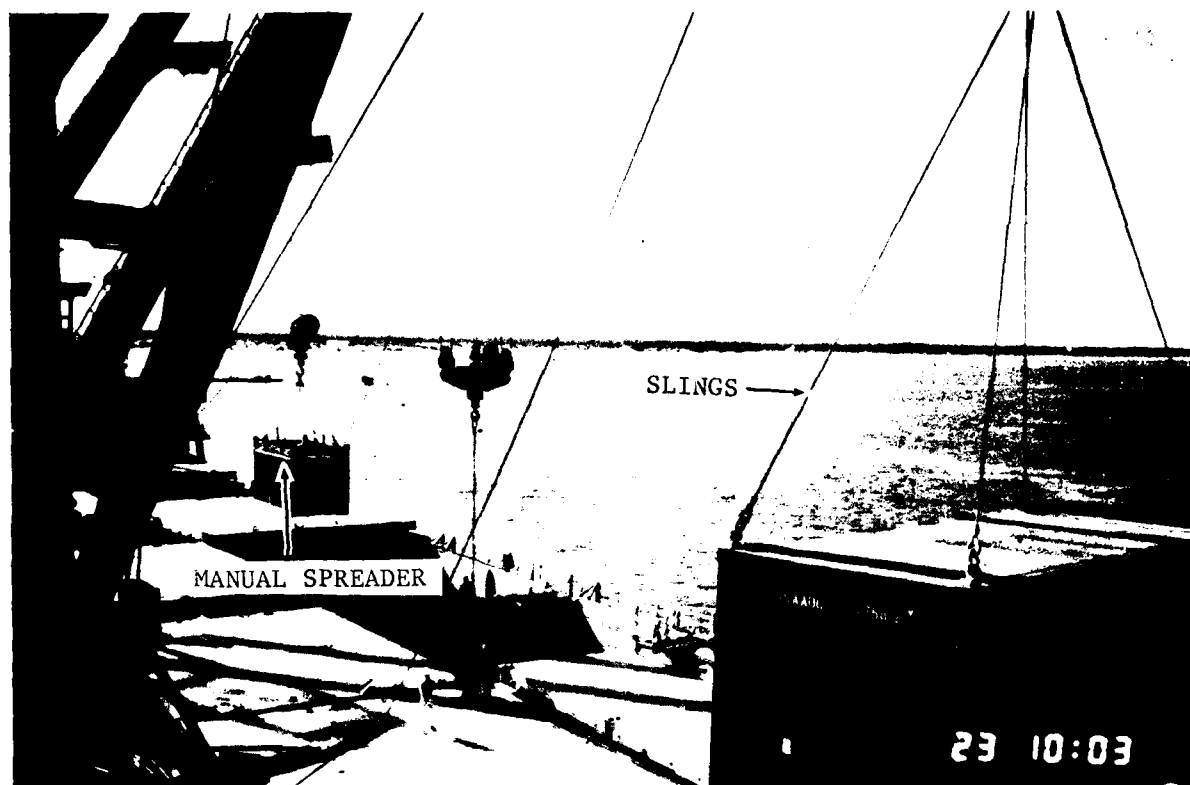
Figure 3-30 - Container Slings in Use

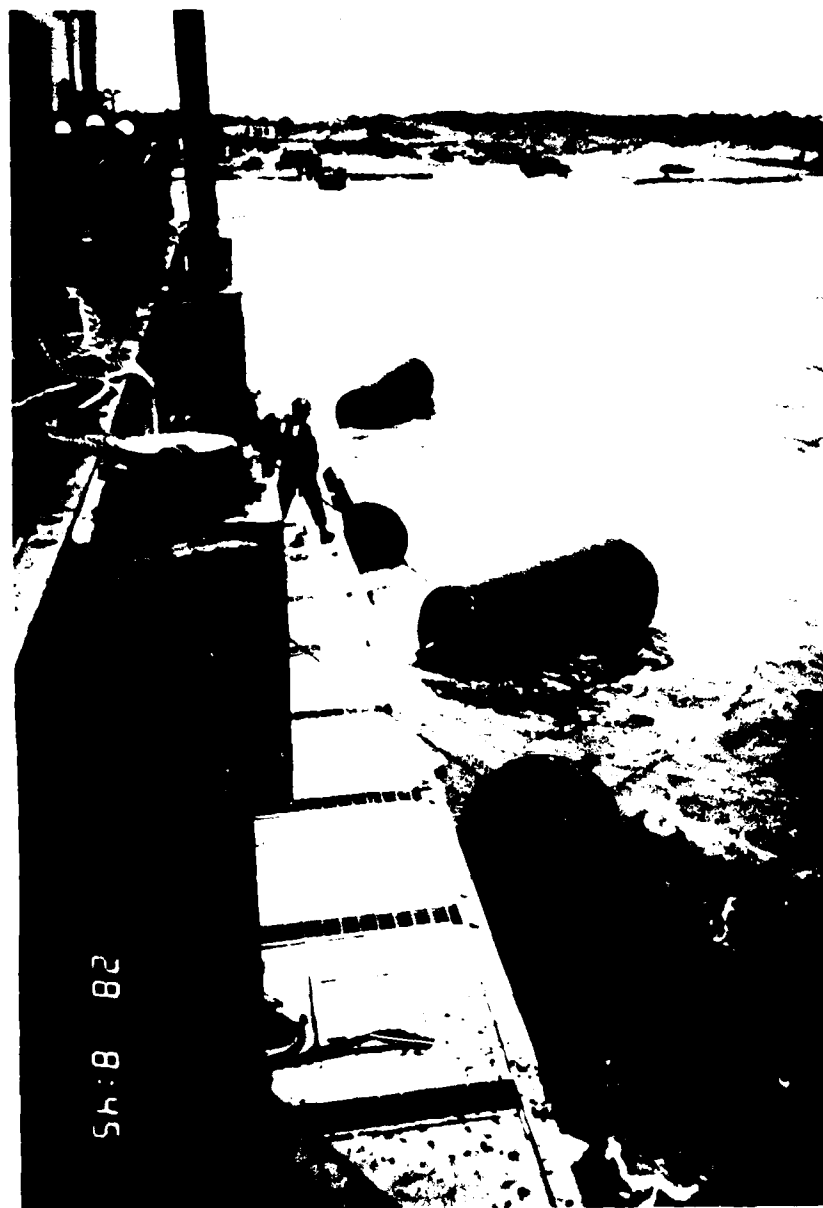
- The ELCAS fender piling, which were supposed to assist in supporting the pierhead, worked loose. The bolts holding the pins at the pierhead, on several of the piling were loosened, and several pins were lost or removed (Figure 3-44). This is a result of lack of maintenance to the pinning system.

Figure 3-43 - ELCAS Fender, Storm Damage

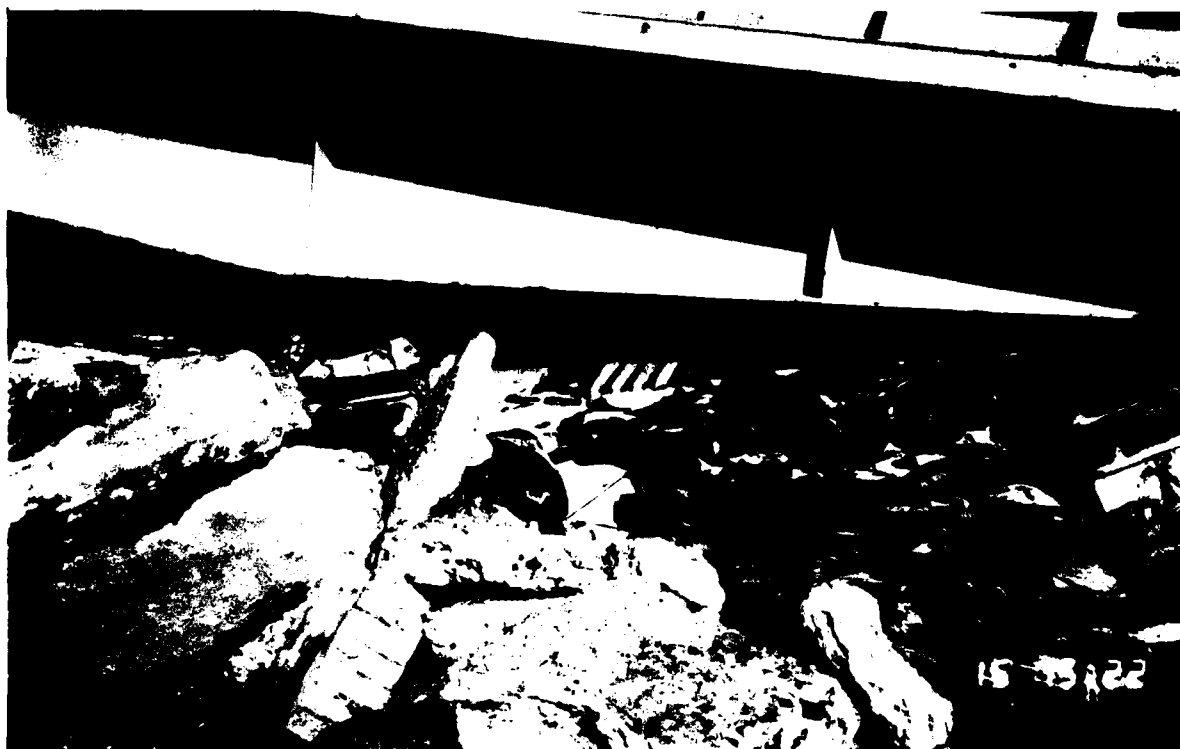
Figure 5-6 - Rubble Protection for DeLong Ramp Abutment

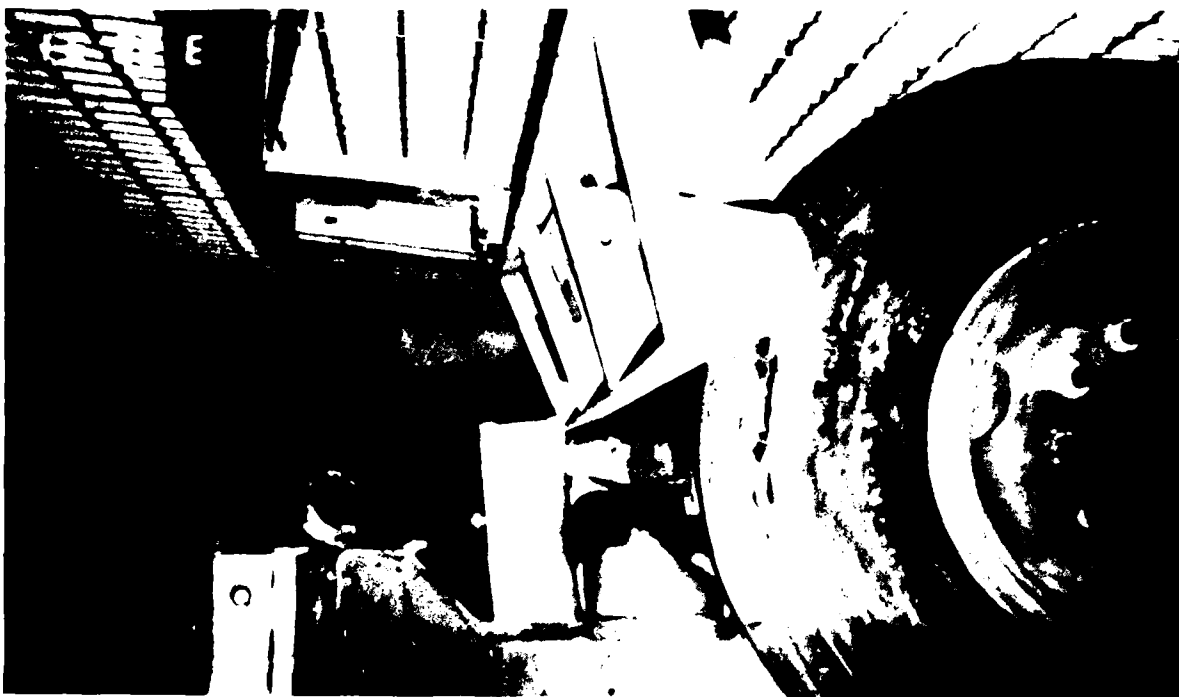
Figure 5-35 - Damage to Turntable Truck Stop
